# Delaware Annual Beach Change Report: **Bay Coast**

**Delaware Department of Natural  
Resources and Environmental Control**

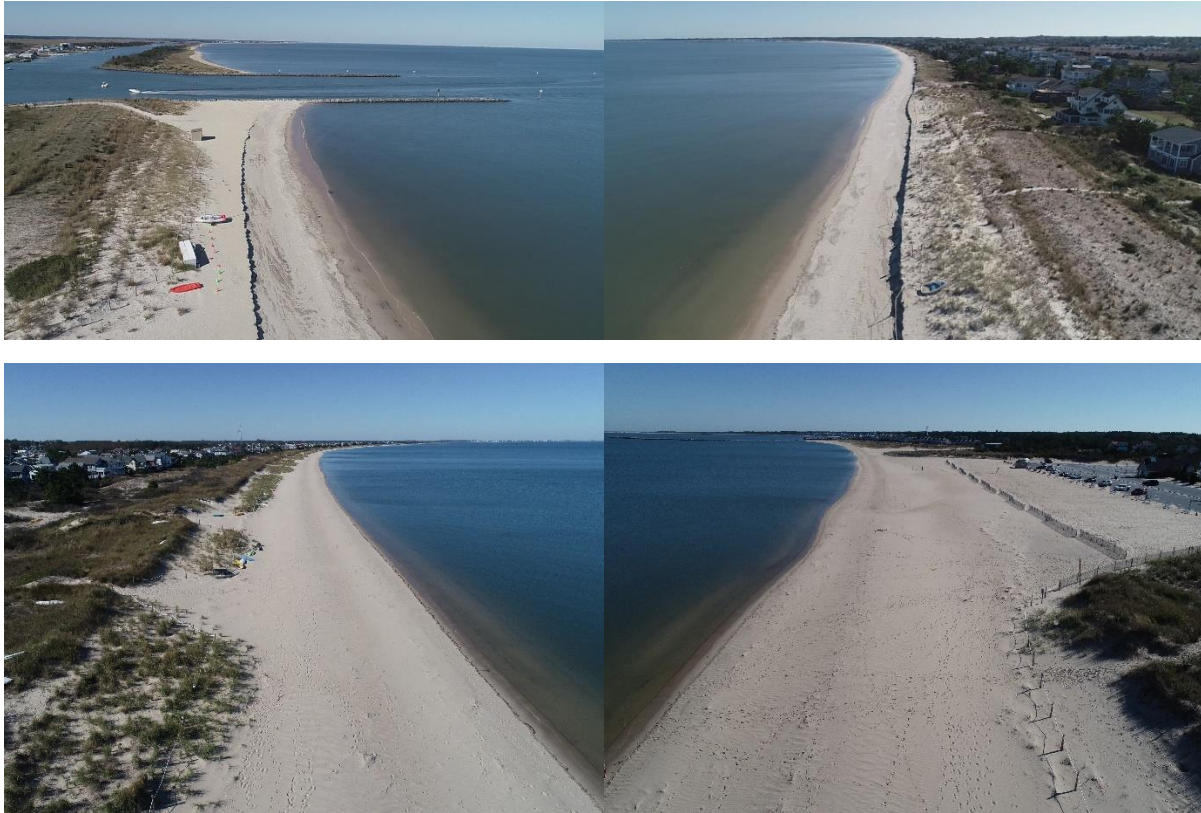
*Figure 8: UAV image of Lewes Beach facing the Roosevelt Inlet (left) and middle of the community (right) taken on November 4<sup>th</sup>, 2020. The top two images were taken at the west end of the community while the bottom were taken on the eastern end.*

A representative photo of the conditions at Lewes Beach along LRP 31 is shown below; the remaining pictures are contained in Appendix A-2. It can be seen in the photo that the dune is scarped, and the

beach width varies along the coast. It is most narrow in a segment that is roughly 500' east of the Roosevelt Inlet.

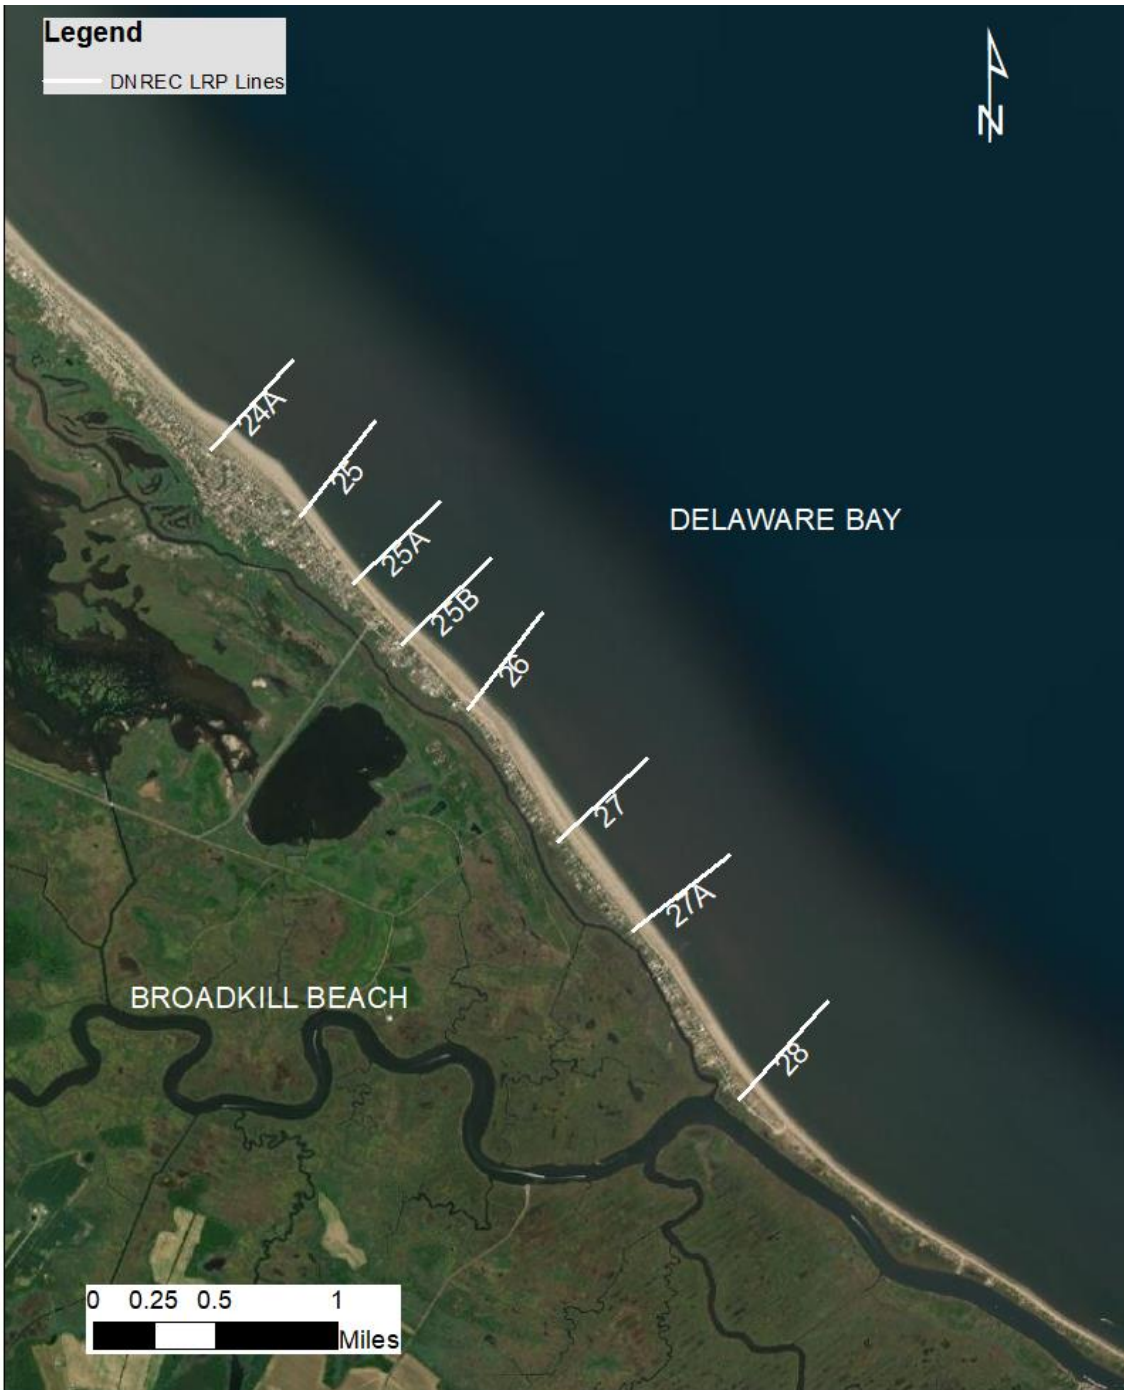
Figure 11: LRP location map in Broadkill Beach

Broadkill Beach is situated between Lewes Beach and Prime Hook Beach. It is roughly 16,000' or three miles in length and includes nine survey lines. Survey lines are spaced roughly 2,000' at the south end of the community and 1,500' in the more developed northern end of the community. In 2016/2017, the USACE placed 1.7 million cubic yards (cy) of sand dredged from the Delaware River onto Broadkill Beach to widen the beach by 150' and to add a dune with a crest of 15-16'.

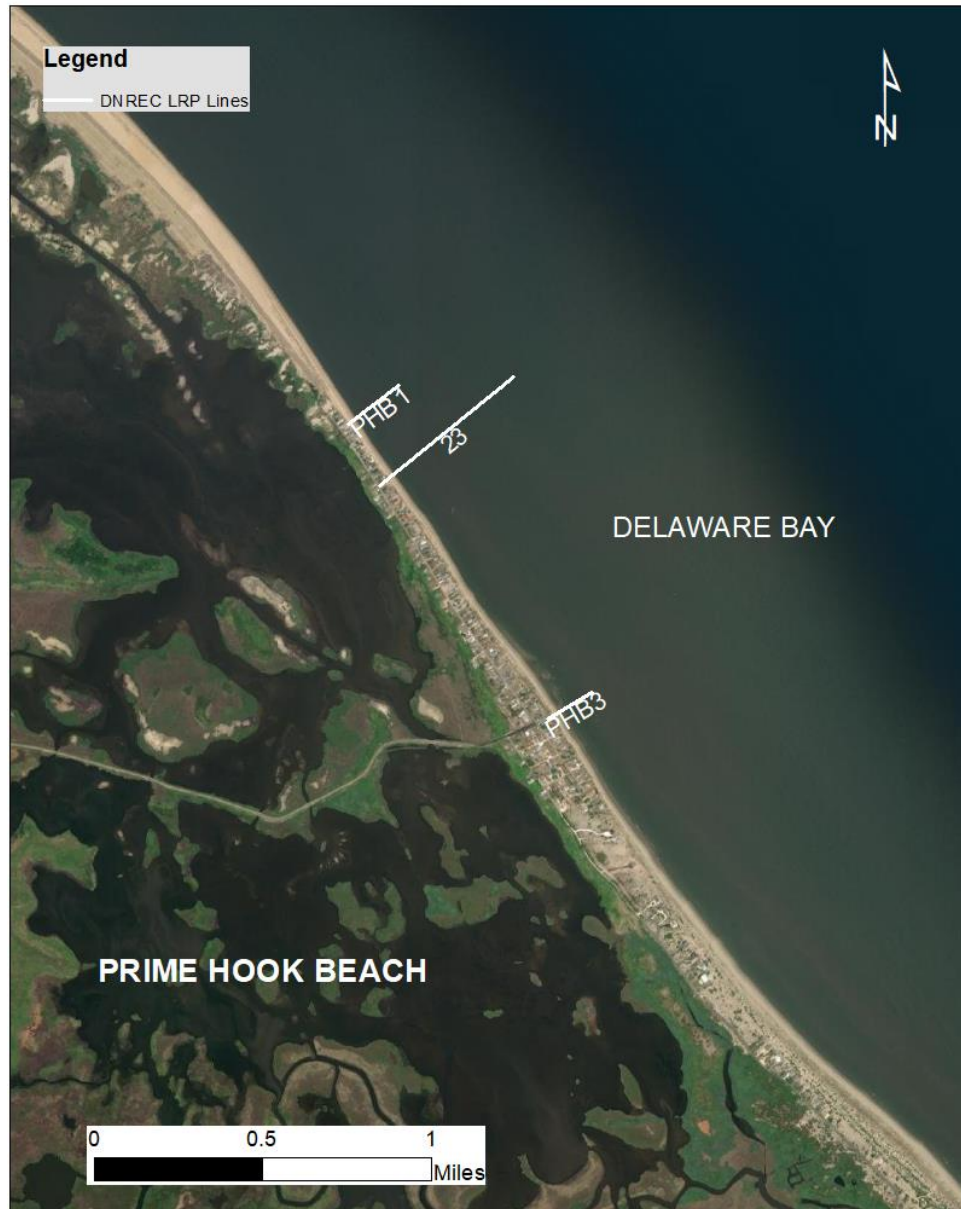
Figure 16: LRP survey lines in Prime Hook

Prime Hook is directly north of Broadkill Beach and is approximately 10,000 feet long. It is a densely developed private beach and contains three survey lines.

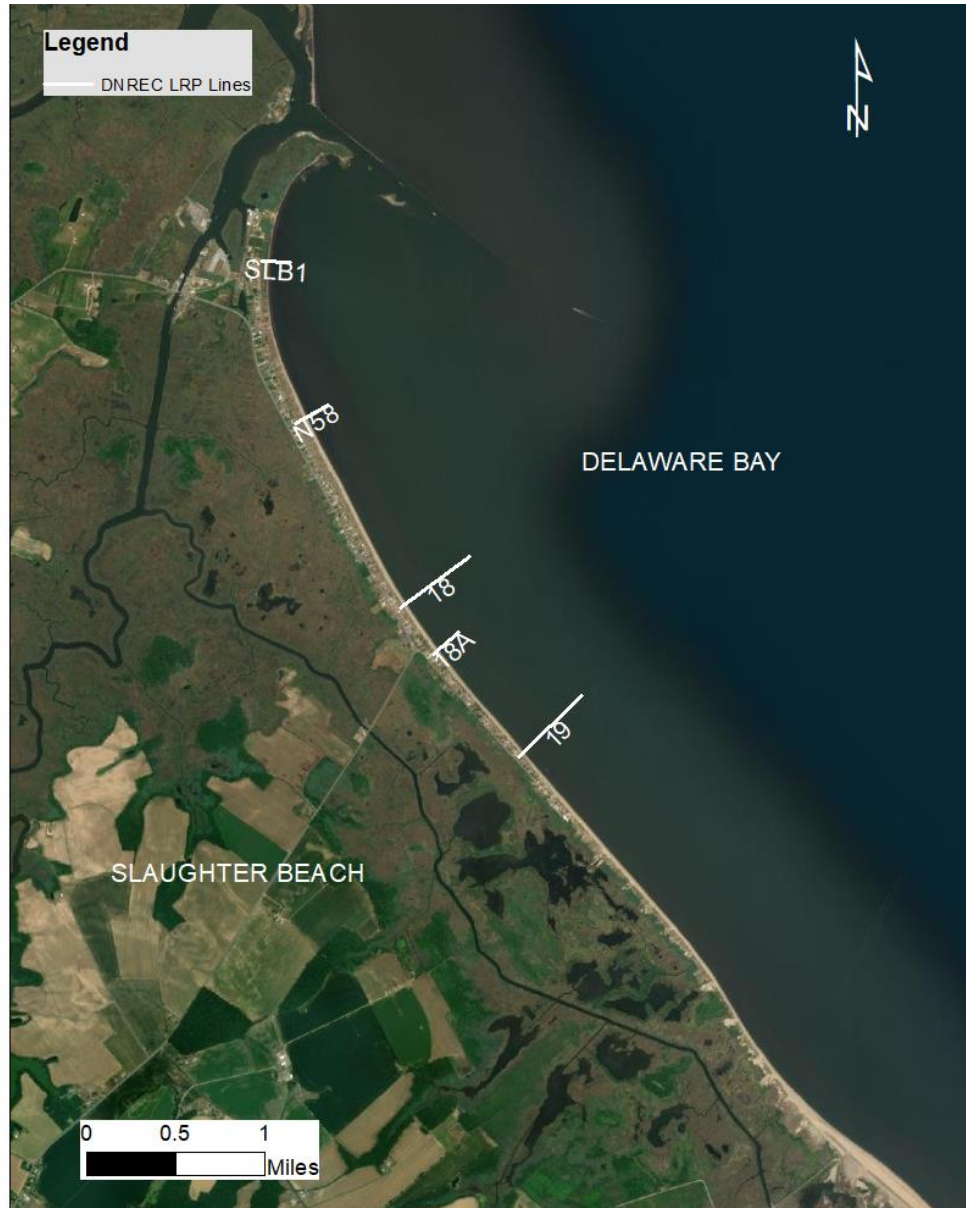
Figure 18: LRP locations in Slaughter Beach

Slaughter Beach is directly north of Prime Hook and contains five survey lines. It is roughly 16,000' or about three miles in length. Not all five lines were surveyed every season, therefore, the four lines that were surveyed are used for the calculations.

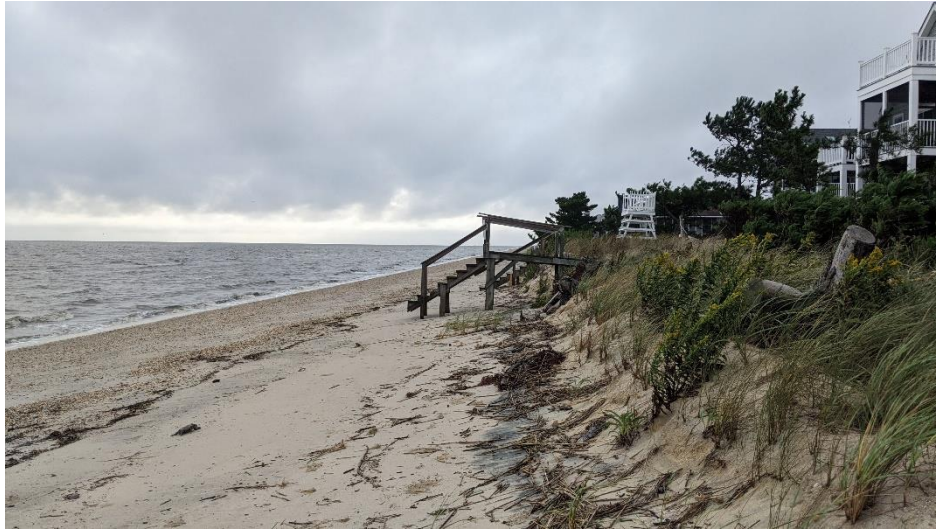
*Figure 20: Slaughter Beach at high tide following an erosive storm*

The nor'easter that occurred in early October caused the tide to reach the seaward edge of the dune, which induced a small scarp in the dune and caused erosion of the berm. The scarping of the dune was less stark near the center of the community at LRP 18. Further south, the upland terrain is greater in elevation making the scarp higher and more vulnerable to collapse. Erosion was not reported nor observed further north along the shoreline where the coast is sheltered due to the south/southeast orientation.

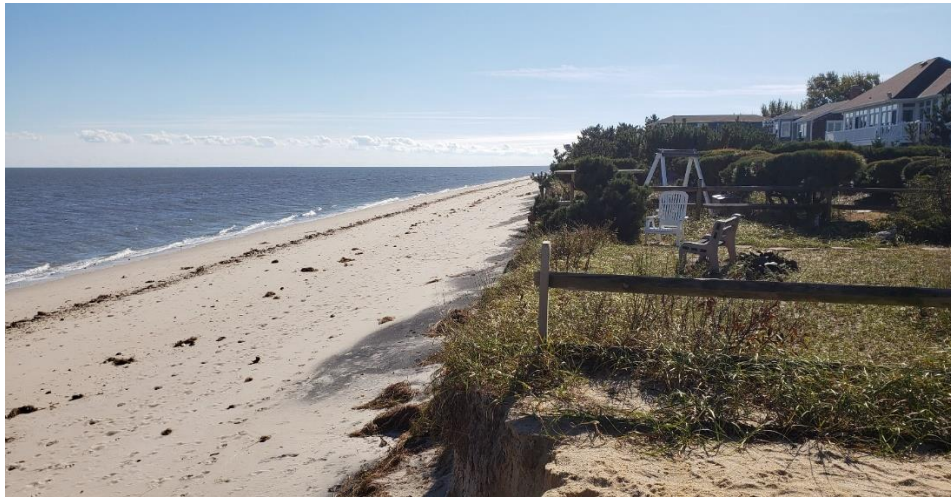
*Figure 21: Severe erosion creating an unstable, vertical scarp in Slaughter Beach*

Additional dune and beach were likely eroded during the last October storm.

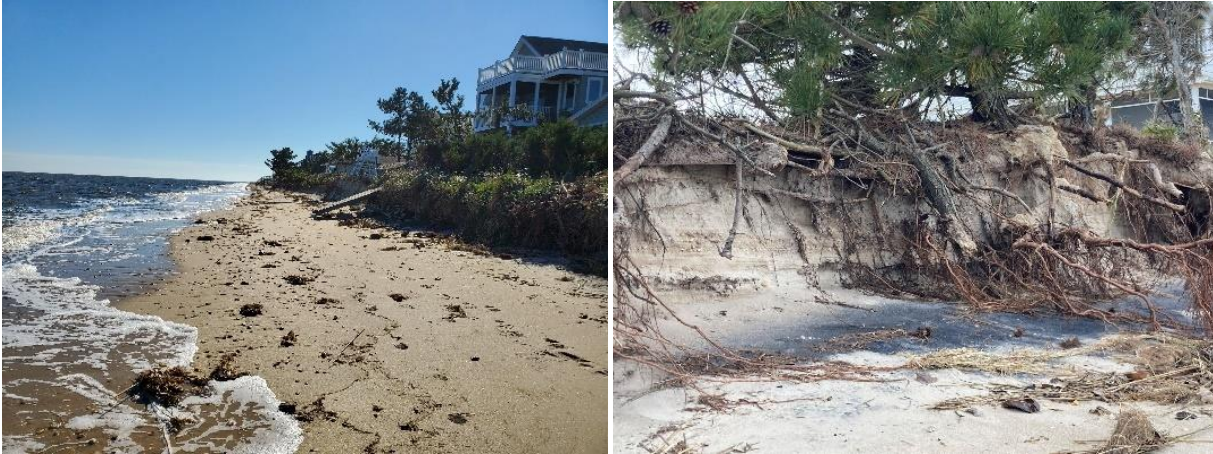
*Figure 22: Slaughter at high tide (left) and a japanese black pine in Slaughter Beach that was undercut during fall storms.*

The nor' easter in early November further damaged the beach and dune at Slaughter Beach leading to washed out trees, beach access structures and exposed bulkheads. A homeowner mentioned that this storm along with the previous nor' easter caused the most erosion he has seen in 40 years.

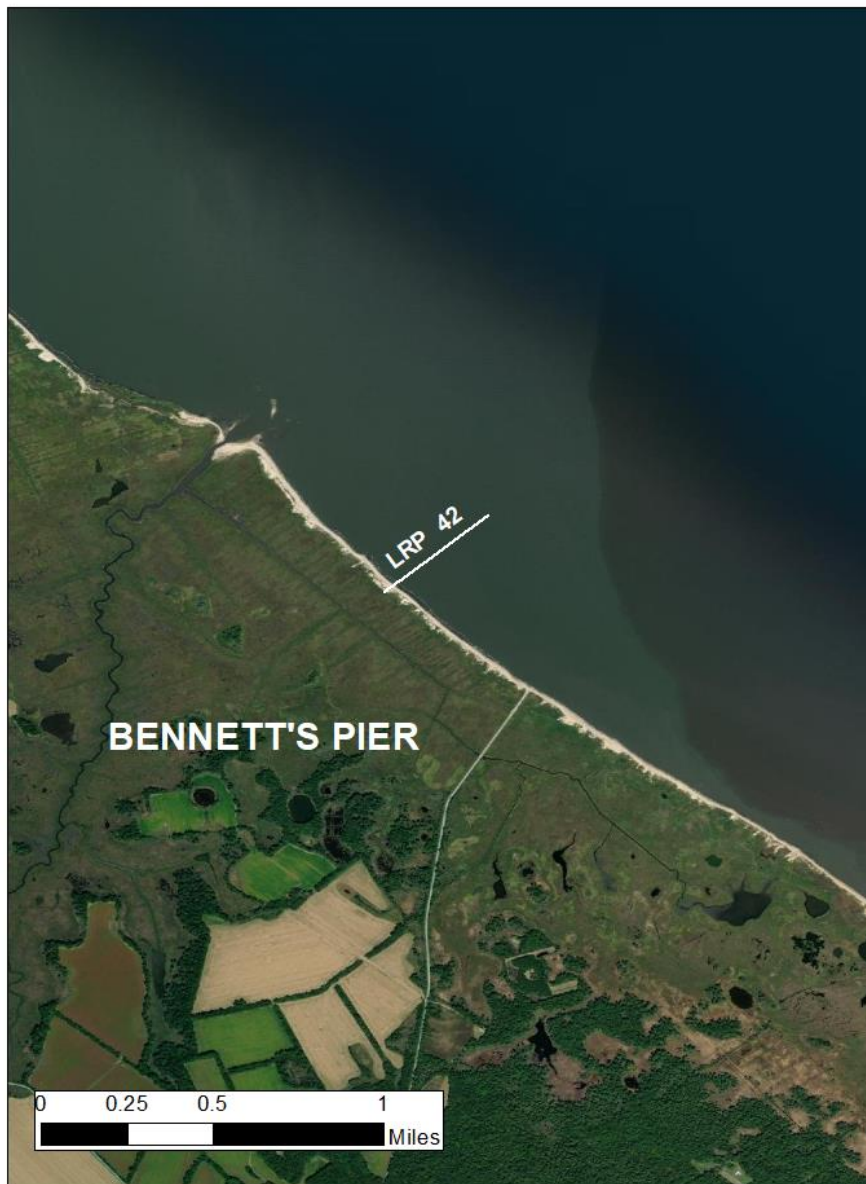
Figure 23: Location of the single LRP line at Bennett's Pier

Bennett's Pier is directly north of Big Stone Beach and contains just one survey line. At present time, this segment of the coast is entirely privately owned, undeveloped and is backed by marshland. DNREC collects data at this location through an agreement with the landowner, Delaware Wildlands Inc.

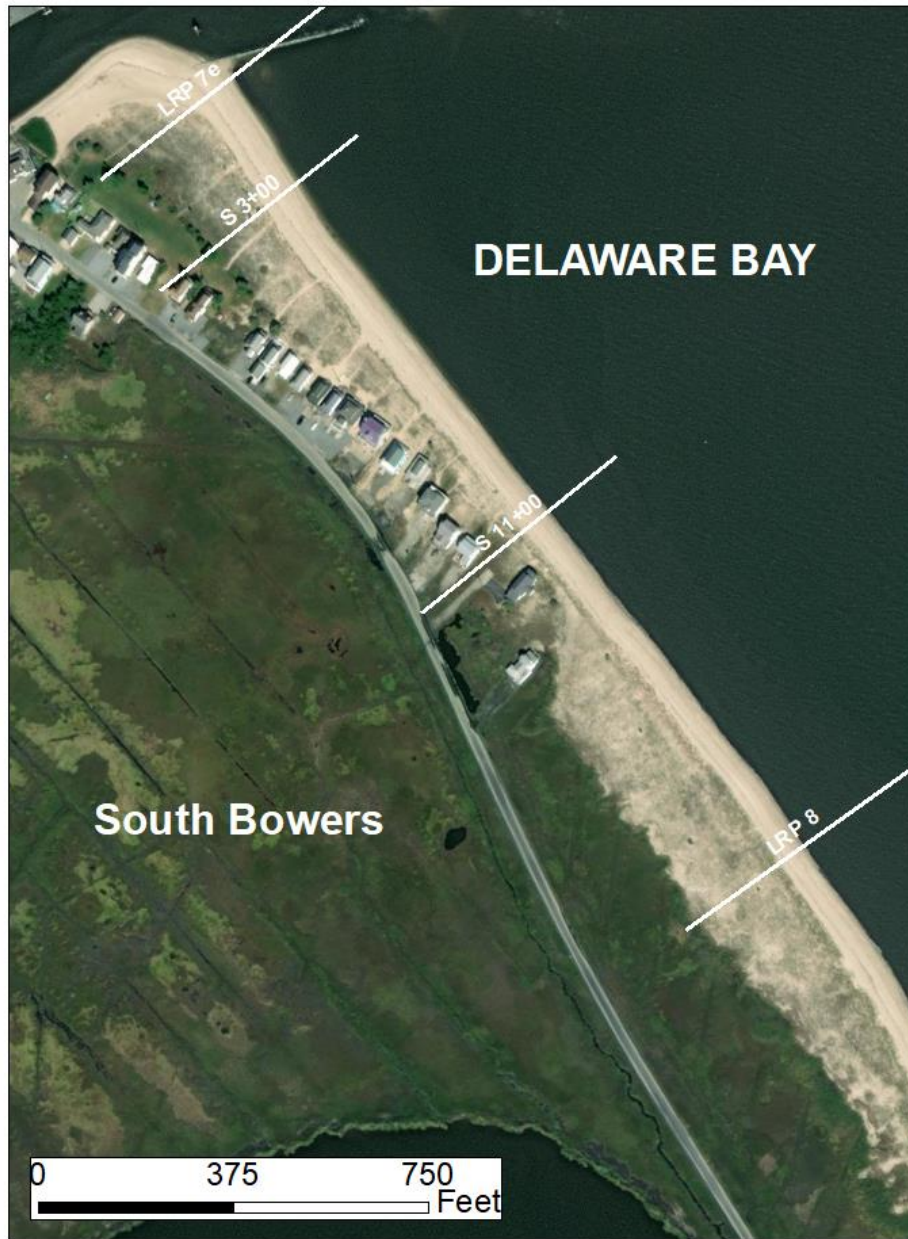
Figure 26: LRP location map in South Bowers

Directly north of the Bennett's Pier is South Bowers Beach, which is undeveloped in the southern half of the community and densely populated near the inlet of the Murderkill River. The length of this segment of beach is roughly 3,000'. There are four survey lines in South Bowers; the lines are spaced more closely

together where it is more densely developed.

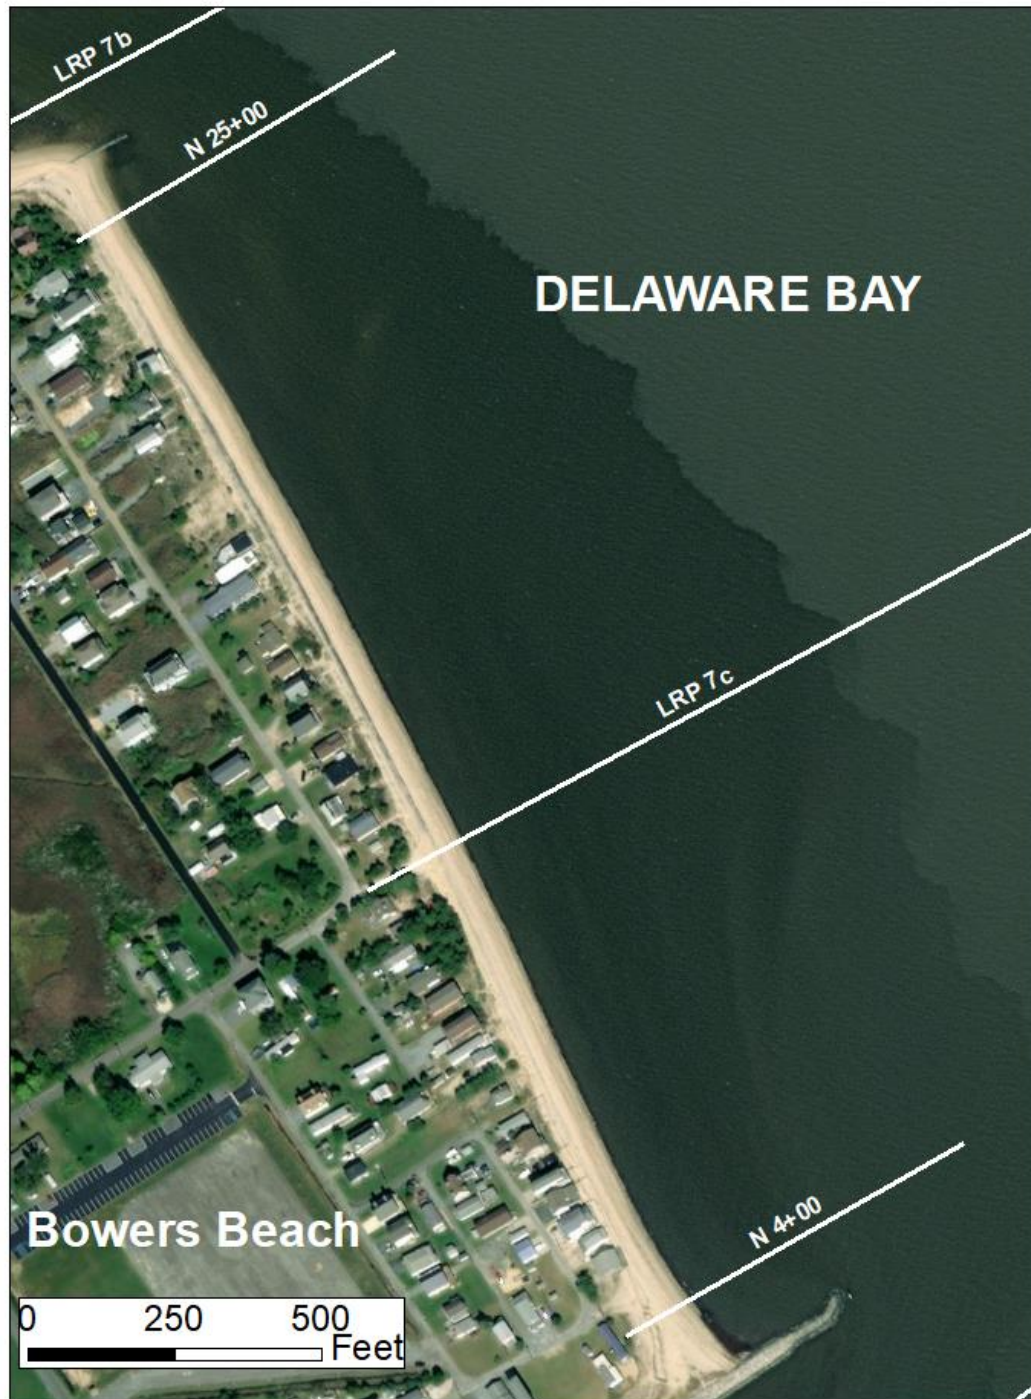
Figure 29: Bowers Beach LRP location map

Bowers is separated from South Bowers by the Murderkill River and is about 2,300' long. The north end of Bowers is bound by the Saint Jones River. Bowers Beach is densely developed. Profile lines are spaced roughly 1,000' in the southern end and densely (250') near the outlet of the St. Jones River. There are three LRP survey lines in the developed portion of the community. There is an additional LRP line north of the northern groin in Bowers where there is no coastal development.

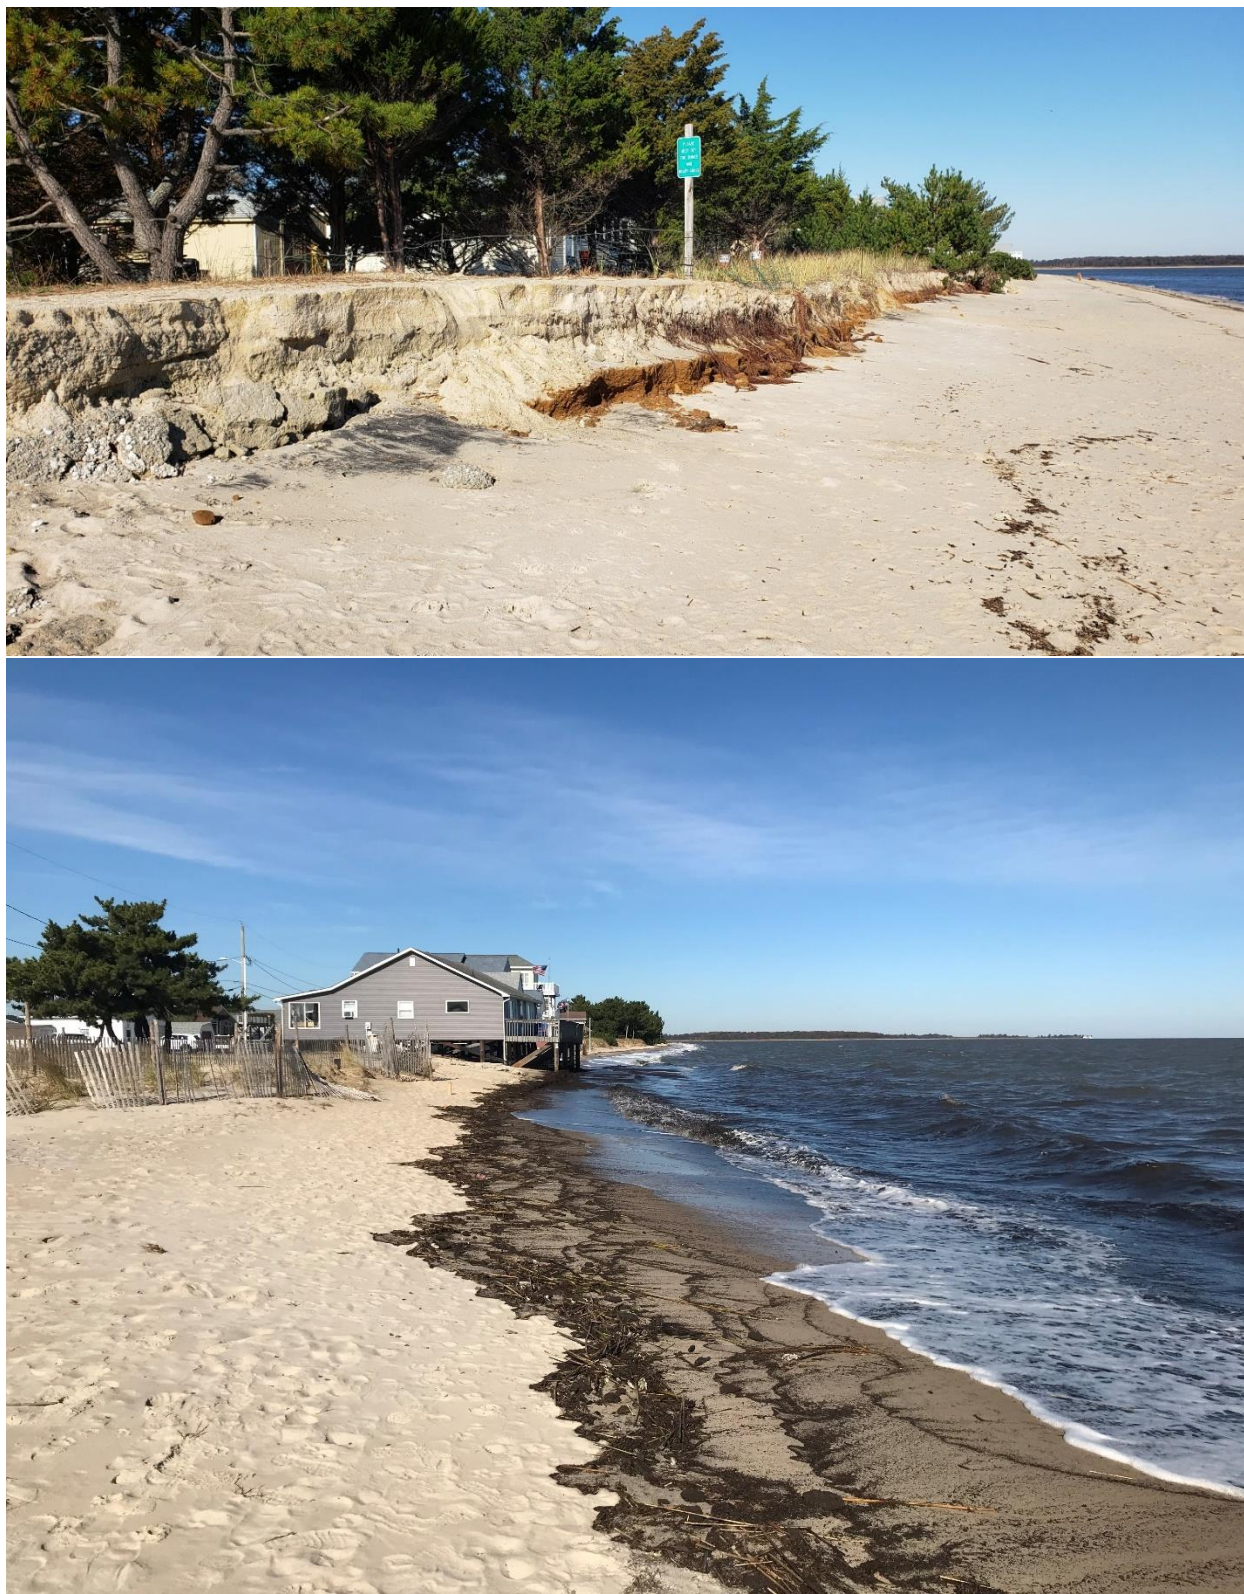
*Figure 31: High tides and erosion resulting from strong east winds*

The early October storm caused minor erosion at Bowers Beach allowing water to lap under one home built upon stilts at the south end of the community. The second event in October caused a significant loss of the dune along the entire beach in Bowers.

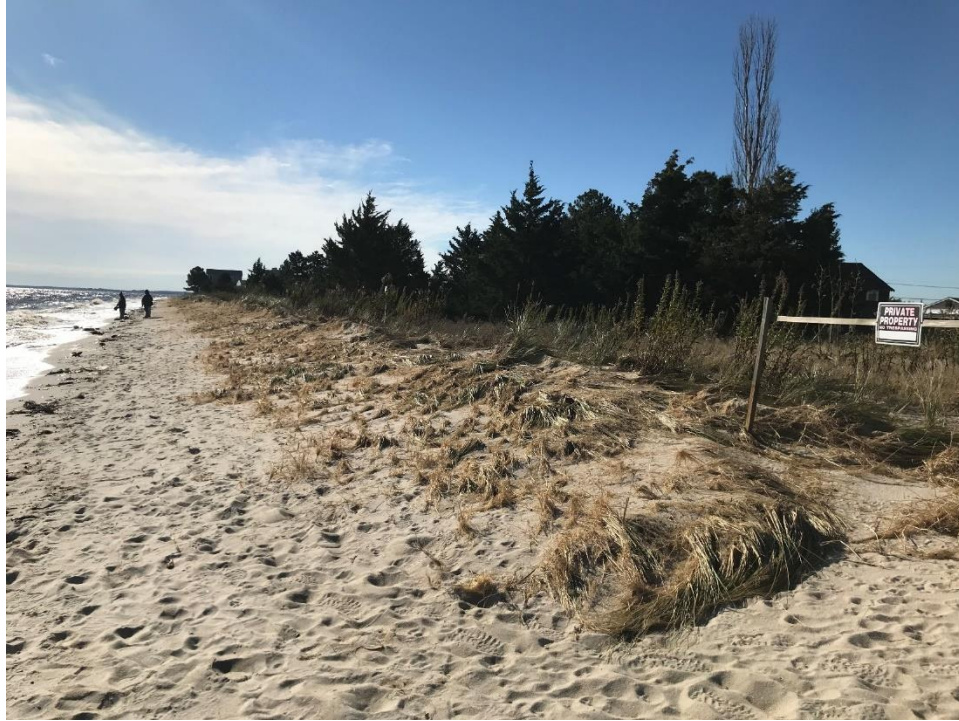
*Figure 34 High tide at Kitts Hummock during a strong easterly storm*

The early October storm caused very minor scarping at the south end of the beach; the other October storm caused a minor loss of the dune. During the November storm, the high-water line, was about 15' away from the toe of the dune.

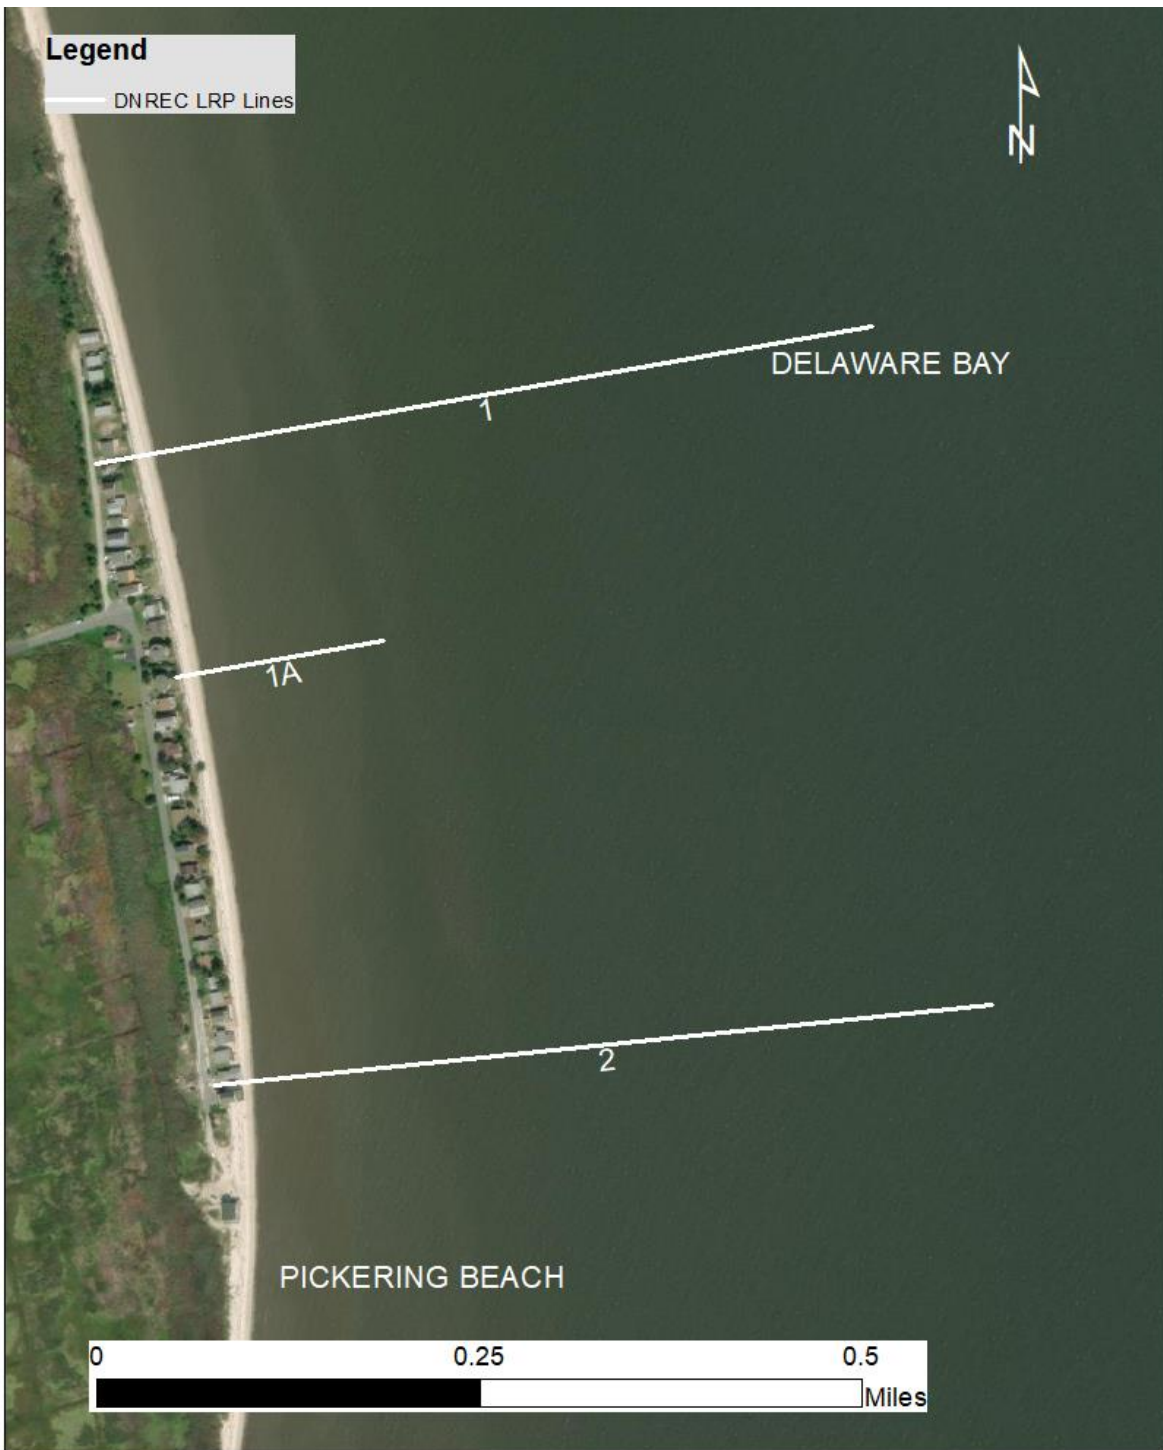
Figure 35 Northernmost LRP located in Pickering Beach

North of Kitts Hummock is Pickering Beach, which consists of three survey lines over 2,300' and is densely developed.

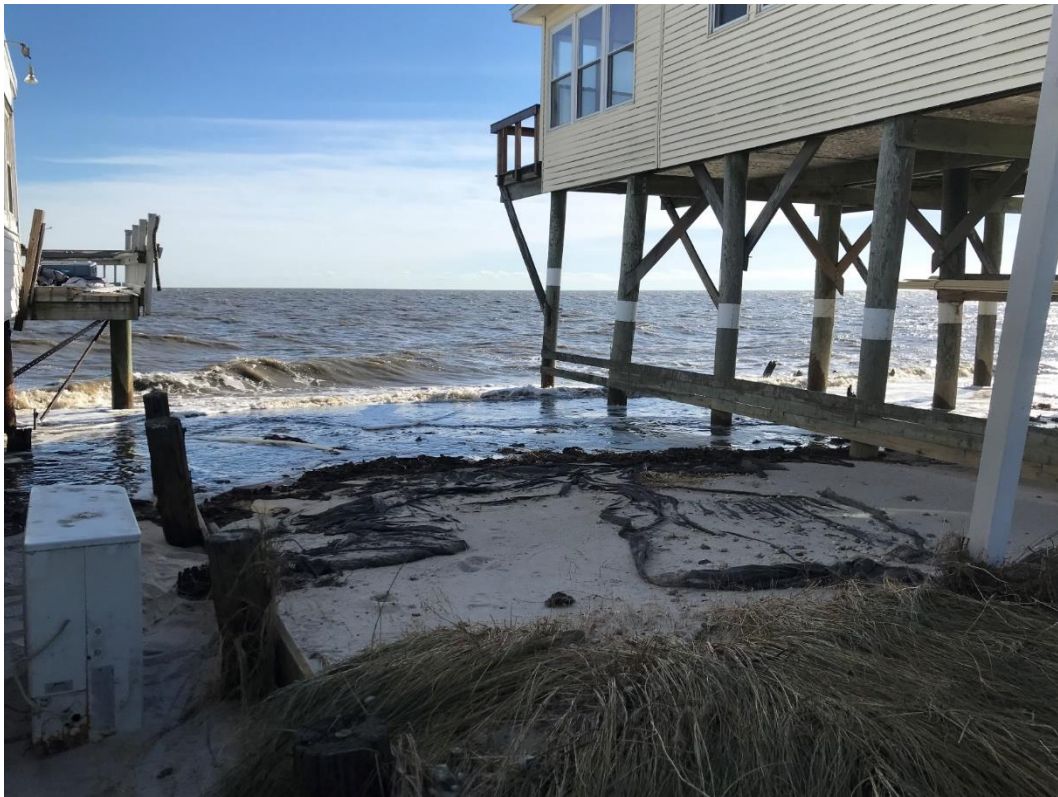
*Figure 38 High tide reaching the pilings of homes in Pickering Beach*

During the first nor' easter in October, there was minor impacts (erosion/scarping) in Pickering Beach. The storm in later October caused the dune to erode entirely. During the November storm, the high tide was underneath the homes at the southern end of Pickering Beach causing scour along posts.
